Building skirt restoration on natural stone masonry with retrospective horizontal barrier

Double-shell masonry

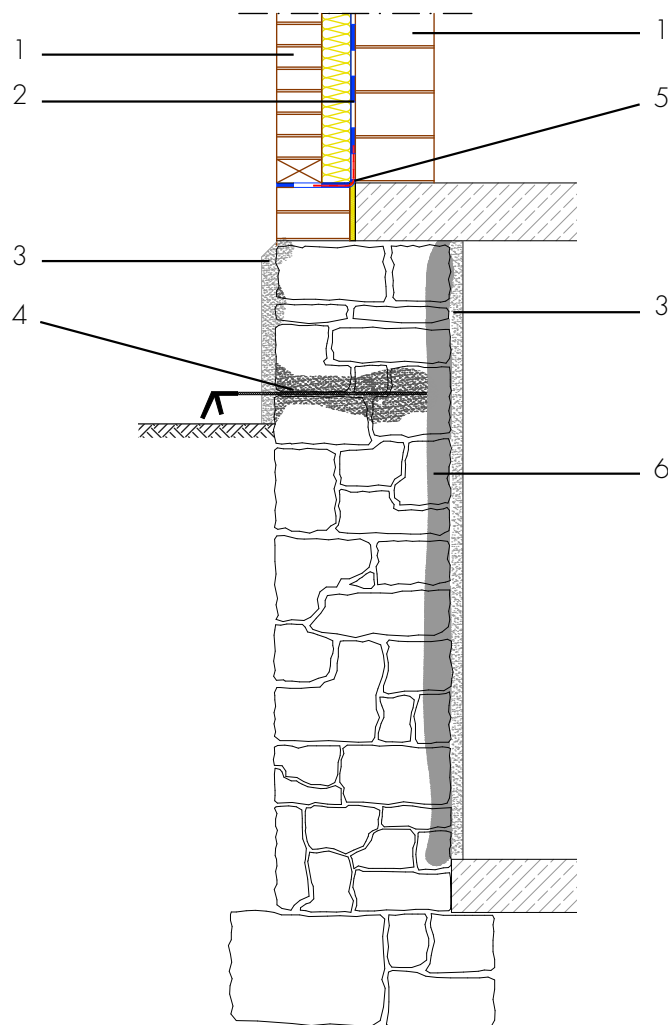
- 1 Backing masonry/front wall shell
- 2 Backing masonry waterproofing - AQUAFIN-RB400 - Protection of the building envelope from damp and foreign matter
- 3 Restored render incl. sprayed plaster - THERMOPAL-ULTRA - Restoration render system for the absorption of salts harmful to buildings
- 4 Retrospective horizontal barrier - AQUAFIN-i380 - Installation of a retrospective horizontal barrier to prevent capillary rise of moisture in masonry
- 5 Waterproofing the abutment joint - ASO-Joint-Tape-2000-S - Installation of a joint tape to safeguard the wall abutment joint from penetrated moisture
- 6 Salt solution - ESCO-FLUAT - Solution of easily soluble chlorides and sulphates to not easily soluble ones
